# Sitio Electrification and Barangay Line Enhancement Program

# Compliances with NEA Standards and Specifications

## Construction: Common Findings

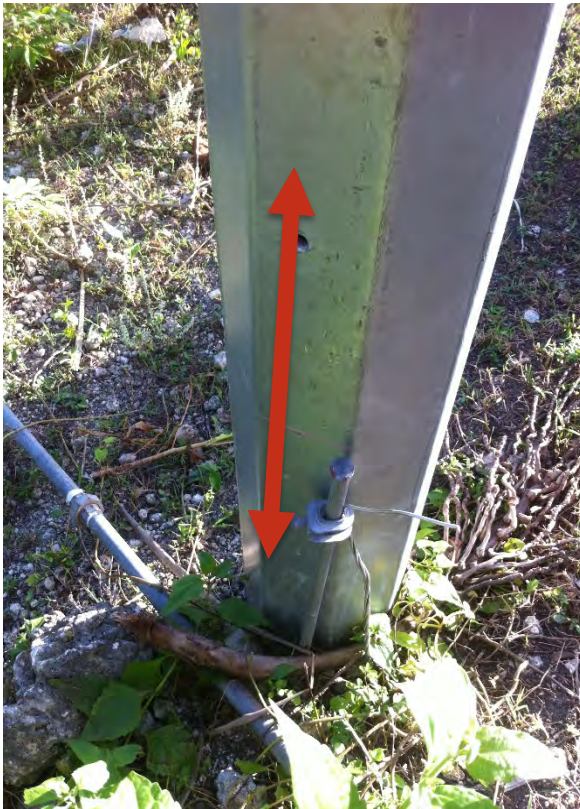
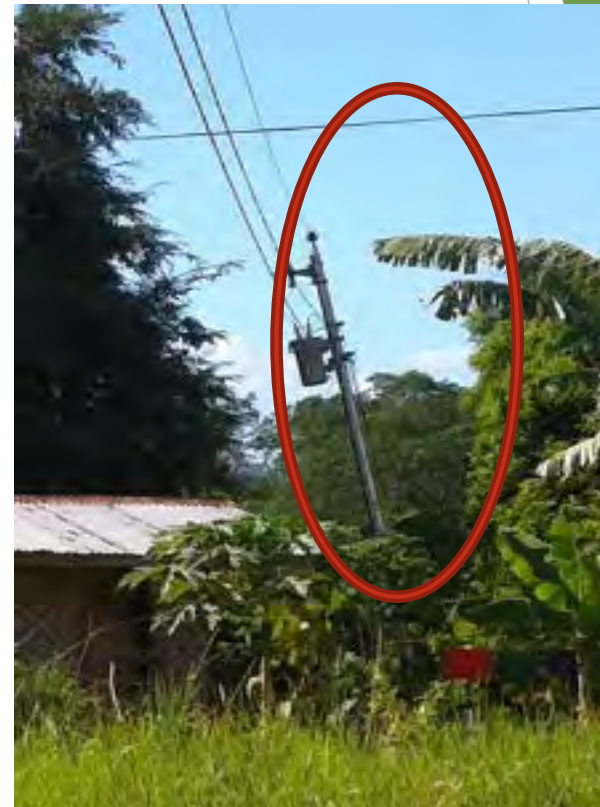
### POLE SETTING

The required depth setting for pole was not followed which resulted to leaning of pole.

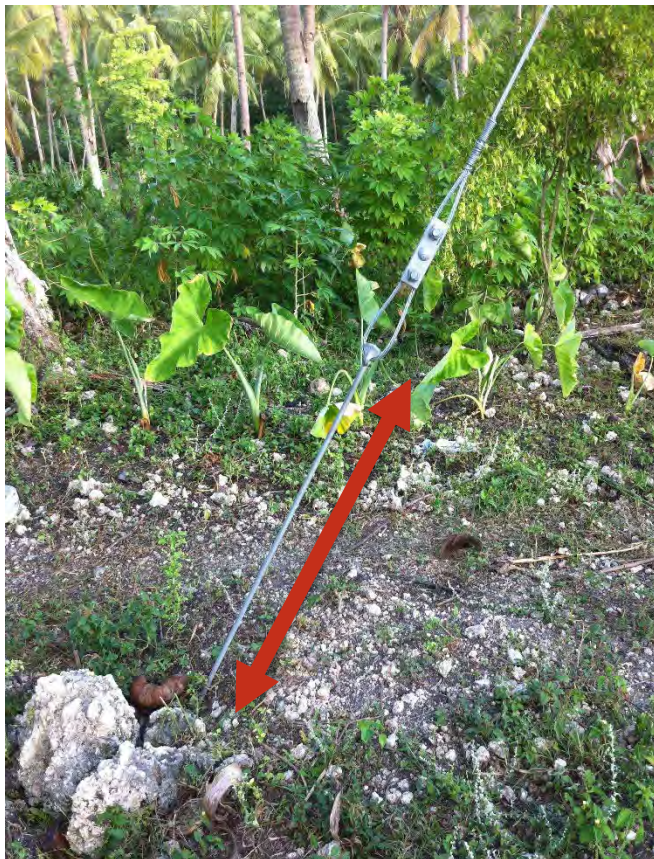
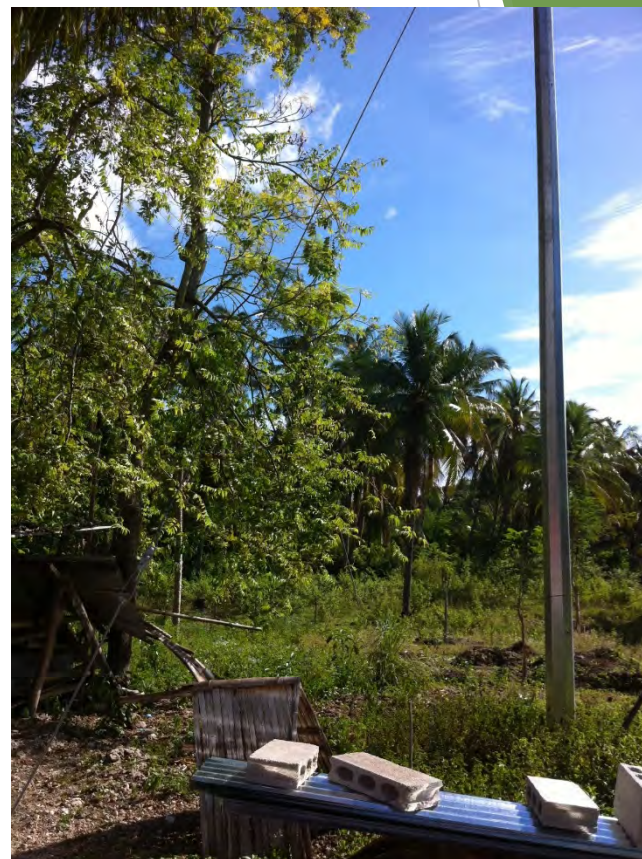
## GUY ASSEMBLIES

Anchor rod was not driven properly to the ground, the top of which shall be at least 12 inches below the surface of the earth.

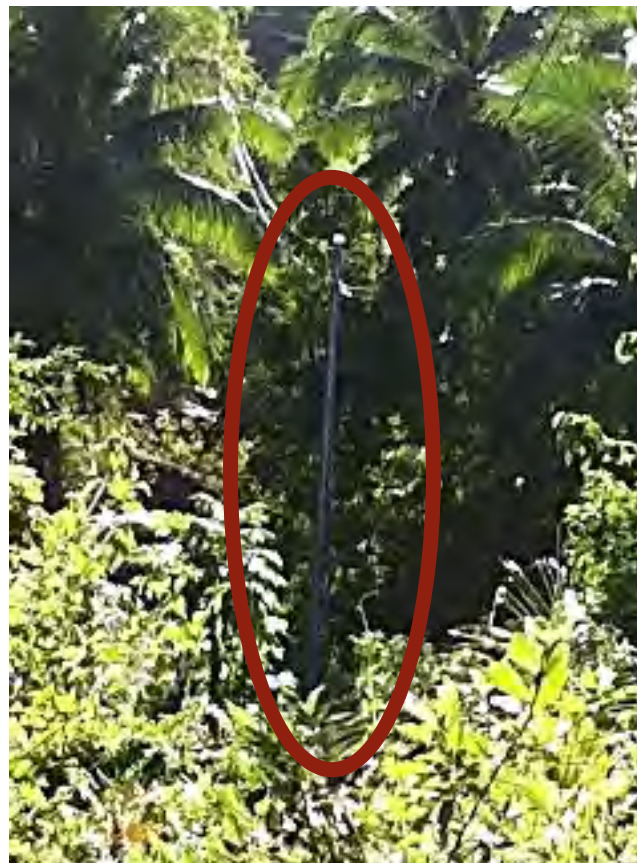
## CROSSING DEPRESSION

Lack of down guys on poles installed on depression areas to prevent uplift.

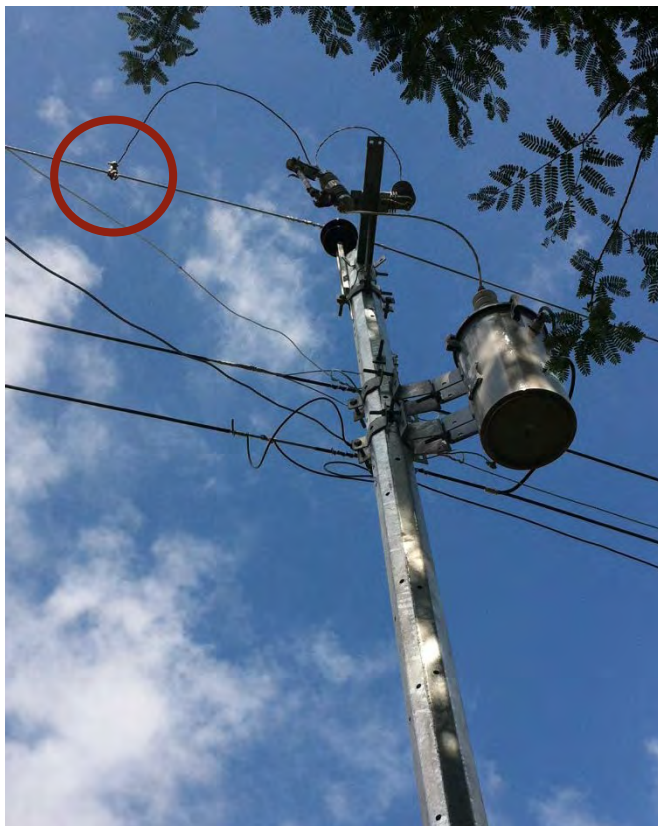
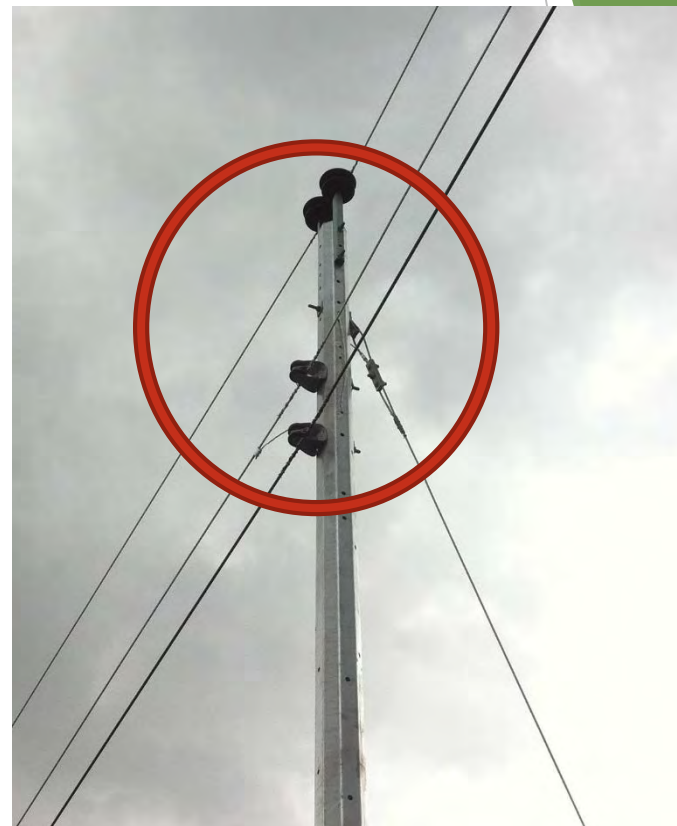
## TRANSFORMER & CONDUCTOR ASSEMBLIES

Lack of armor rod tapping in transformer pole and  
armor rod for primary and secondary line for  
conductor protection.
